INDOOR AIR QUALITY ASSESSMENT

**Furnace Brook Middle School
500 Furnace Street
Marshfield, Massachusetts**

Prepared by:
Massachusetts Department of Public Health
Bureau of Environmental Health
Indoor Air Quality Program
October 2019

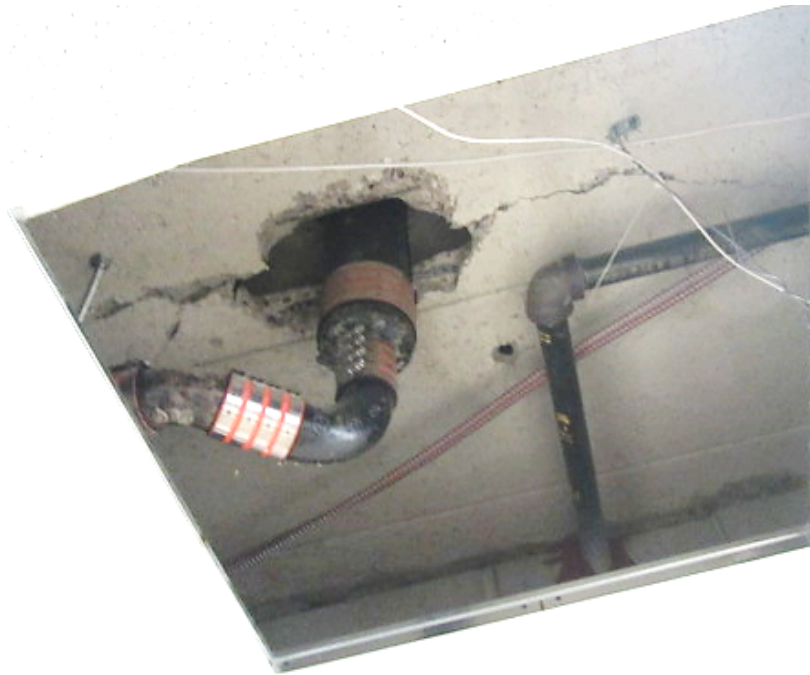
Picture 1

- Conference Room: No measurable levels of TVOCs were detected in the breathing zone at the time of assessment; a slight reading of 2.4 ppm was measured in the utility hole above the ceiling (Picture 1).
- Room 16: No measurable levels of TVOCs were detected in the breathing zone (note that the univent was operating and bringing in fresh air at the time of testing). A slight reading of 1.4 ppm was measured near the sealed skylight above the ceiling (Picture 2).

Open utility hole in Conference Room

4. Seal any/all open utility holes in walls and ceilings in both the Conference Room and Room 16.
5. If odors persist, work with roofing contractor, HVAC specialist and/or an Industrial Hygienist to examine more permanent solutions to remove and/or eliminate source of odors.

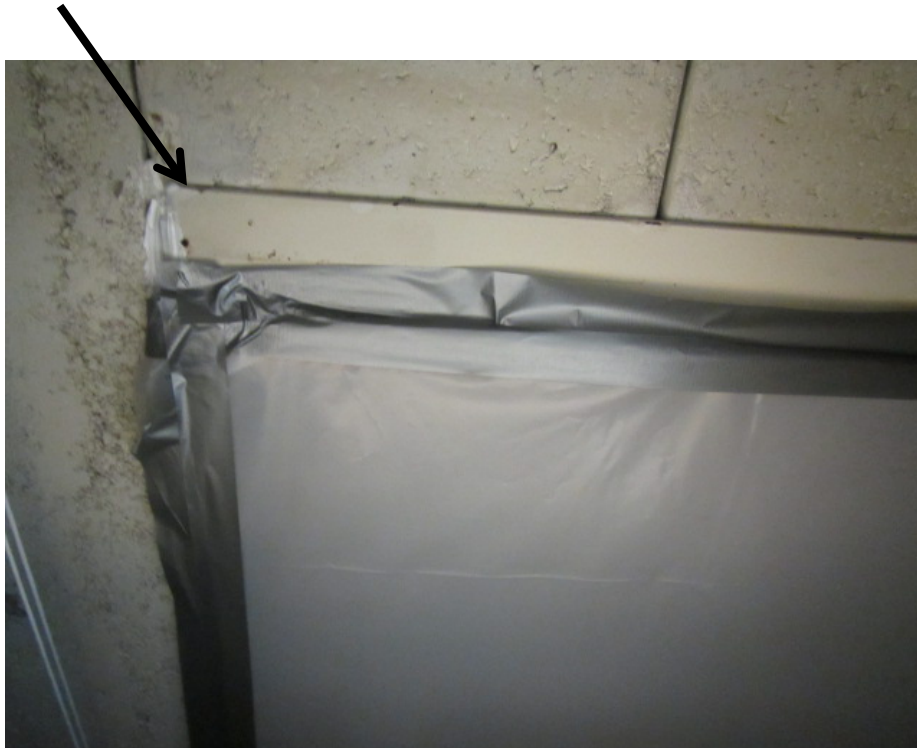
Picture 2

Sealed skylight above ceiling in Room 16, note metal skylight frame (arrow)

1. Ensure skylight is sealed as airtight as possible using caulking or other appropriate airtight sealant. Extend this covering over the metal skylight frame (shown in Picture 2).

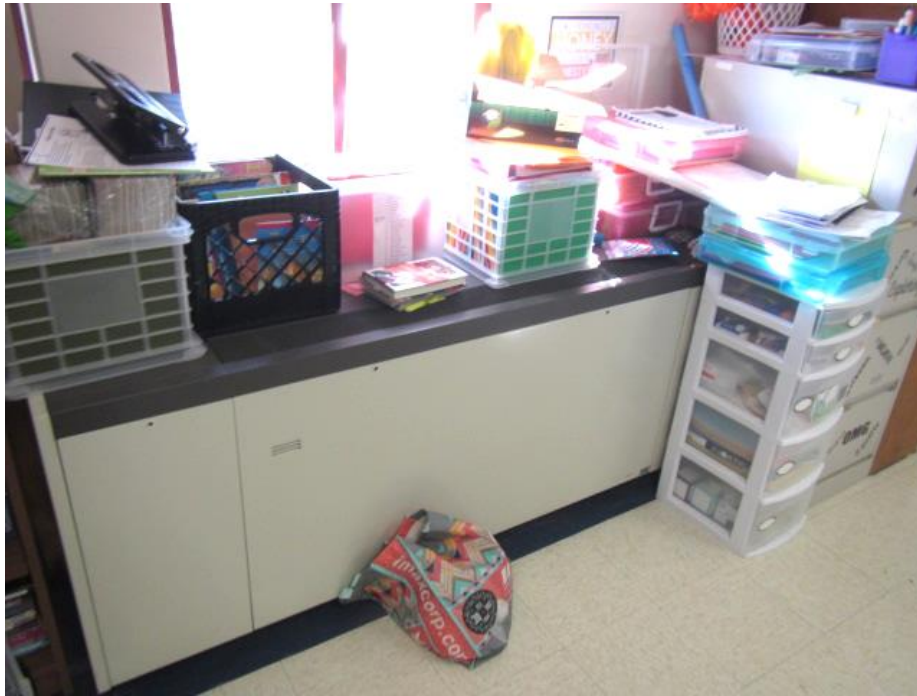
Picture 3

Mechanical ventilation for classroom 16, and most general classrooms, is provided by a unit ventilator (univent) located near classroom windows (Picture 3). Univents draw air from the outdoors through a fresh air intake located on the exterior wall of the building (Picture 4) and return air through an air intake located at the base of the unit. Fresh and return air are mixed, filtered, heated or cooled and provided to rooms through an air diffuser located in the top of the unit ([Figure 1](#)). It is important to note that the univent was reportedly deactivated for several days prior to the odor complaint. It was also reported that once the univent was reactivated odors began to lessen. Not only will operating the univent *dilute* odors by bringing in fresh/outside air but will also *pressurize* the room keeping odors out (e.g., above the ceiling tiles/away from occupants).

Classroom 16 univent

2. Operate univent in Room 16 *continuously* during occupied hours and utilize openable windows to *pressurize* the room in relation to the ceiling plenum.

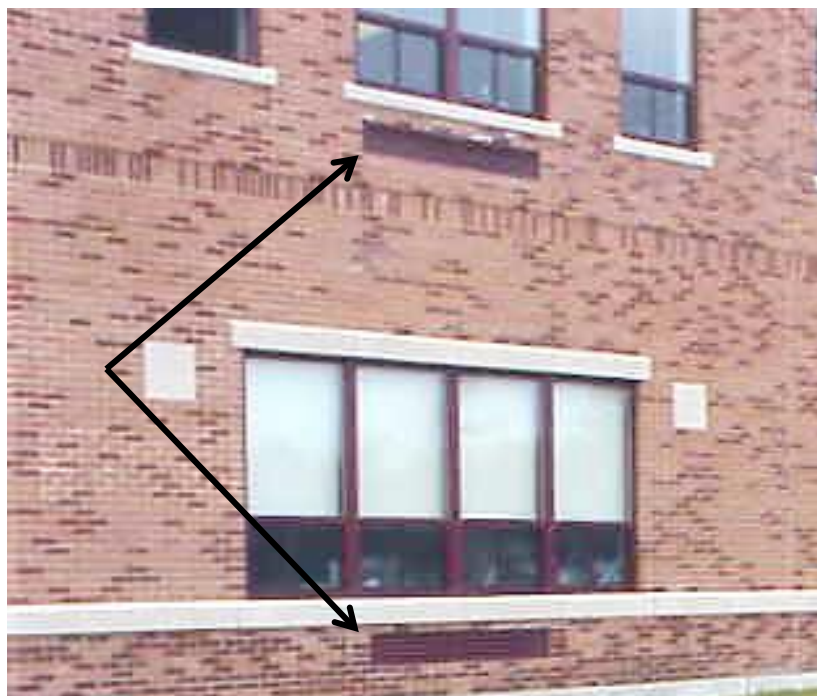
Picture 4

Univent fresh air intakes (arrows)

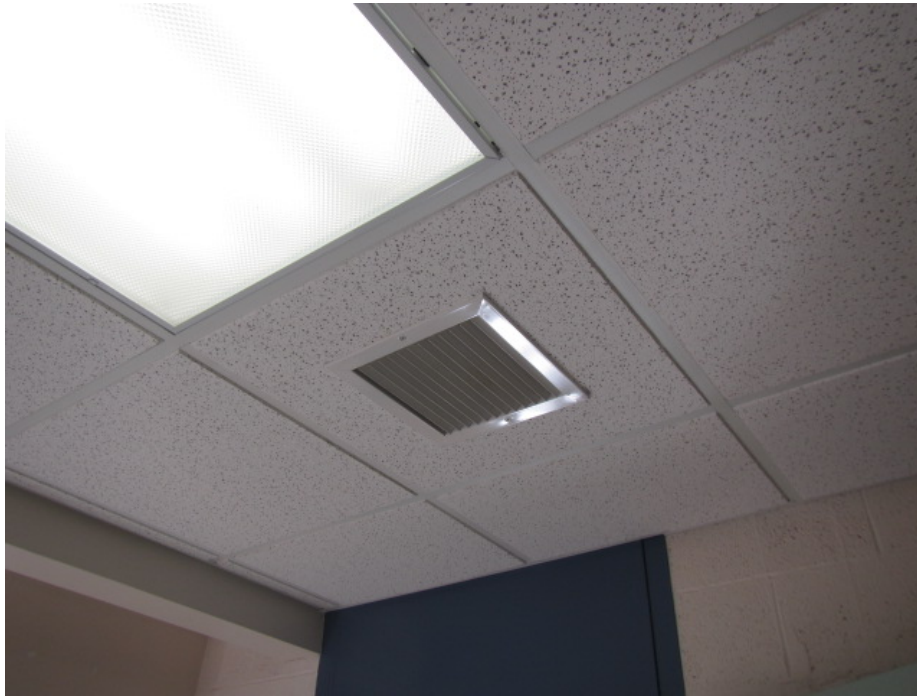
Picture 5

Most classrooms with mechanical ventilation typically have exhaust or return vents installed to remove naturally occurring airborne pollutants and provide air exchange. Room 16 does not have any exhaust/return vents. The Conference Room does have an operable mechanical exhaust vent mounted in the ceiling (Picture 5). BEH/IAQ Program staff recommended installing a vent in the exhaust ductwork above the ceiling (Picture 6) to depressurize the ceiling plenum in relation to the Conference Room, which will capture odors (if present) before they reach the occupied area.

Ceiling-mounted exhaust vent in Conference Room

3. Consider installing a vent or approximate one by drilling holes in the exhaust duct above the ceiling in the Conference Room to *depressurize* the ceiling plenum, which will capture odors (if present) and remove from building.

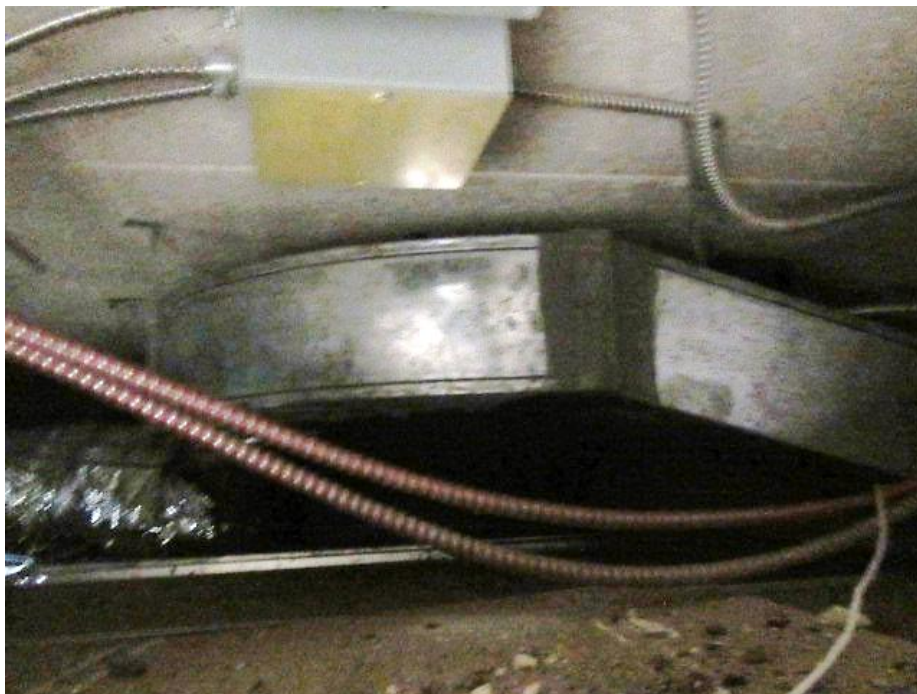
Picture 6

Exhaust ductwork above ceiling in Conference Room
